# Operation UPSHOT-KNOTHOLE

March - June 1953

Project 5.1

ATOMIC WEAPON EFFECTS ON  
AD TYPE AIRCRAFT IN FLIGHT (U)

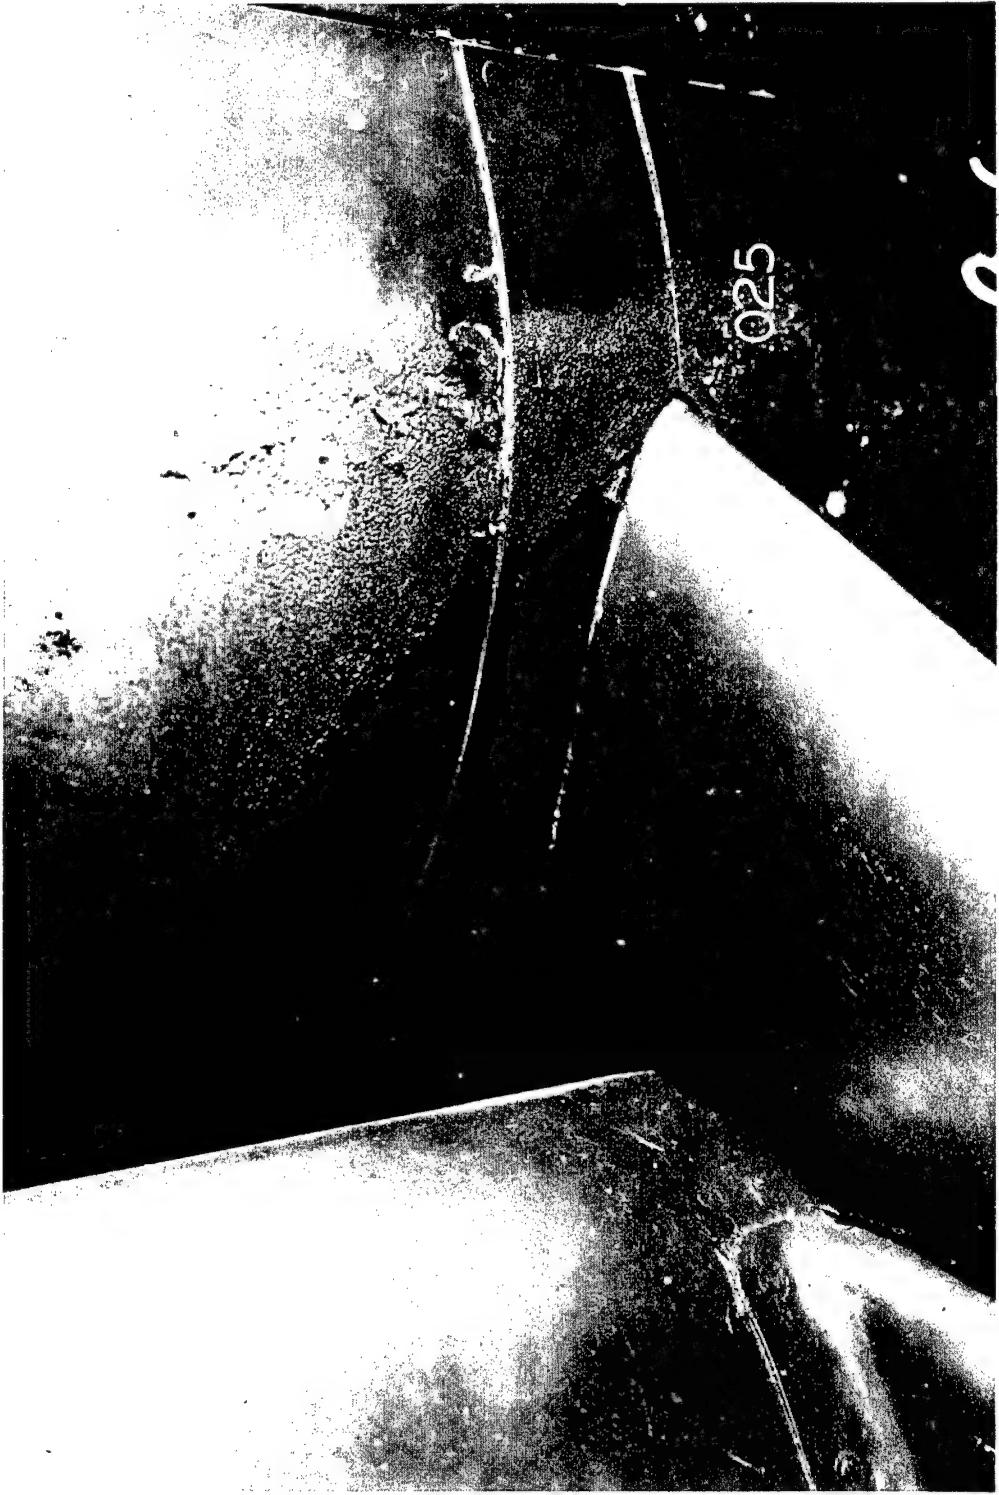
Fig. 2.4 AD-2, Port Wing Flap Showing Scorched Blue Paint on 0.020 Skin,  
and on 0.025 Skin Forming Curved Portion Aft of Rear Shear Web  
Facing the Burst - Shot 2

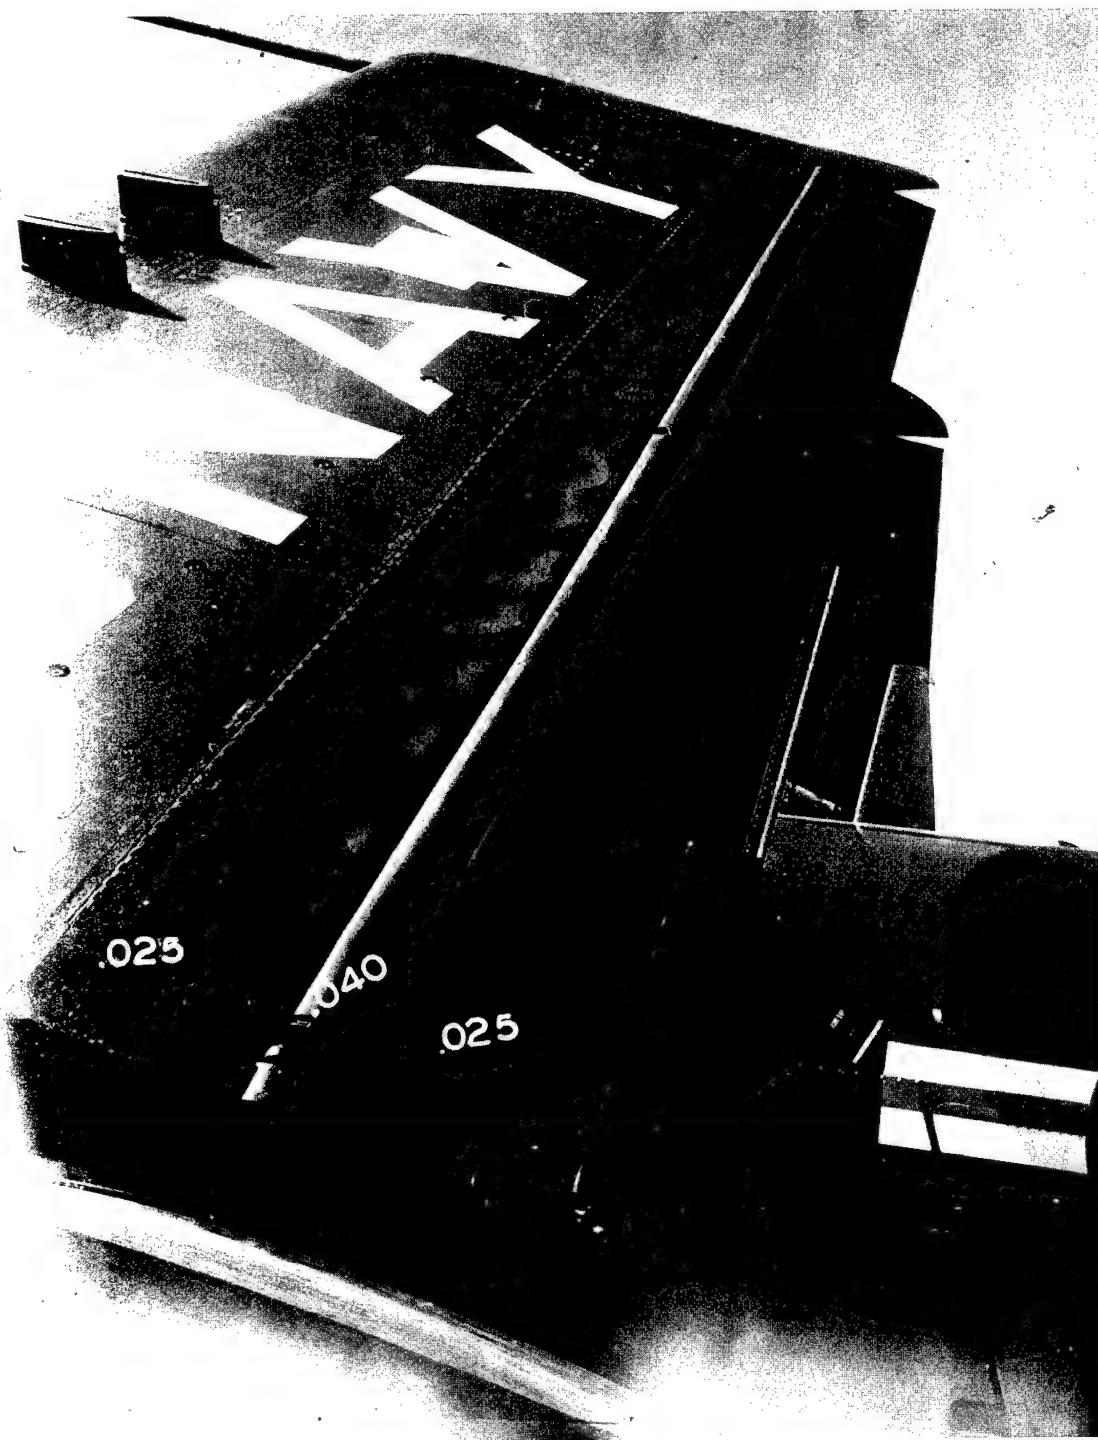
Fig. 2.5 AD-2, Port Wing Flap Showing Scorched Blue Paint on 0.025 Skin Forming Curved  
Portion Aft of Rear Shear Web Facing the Burst - Shot 2

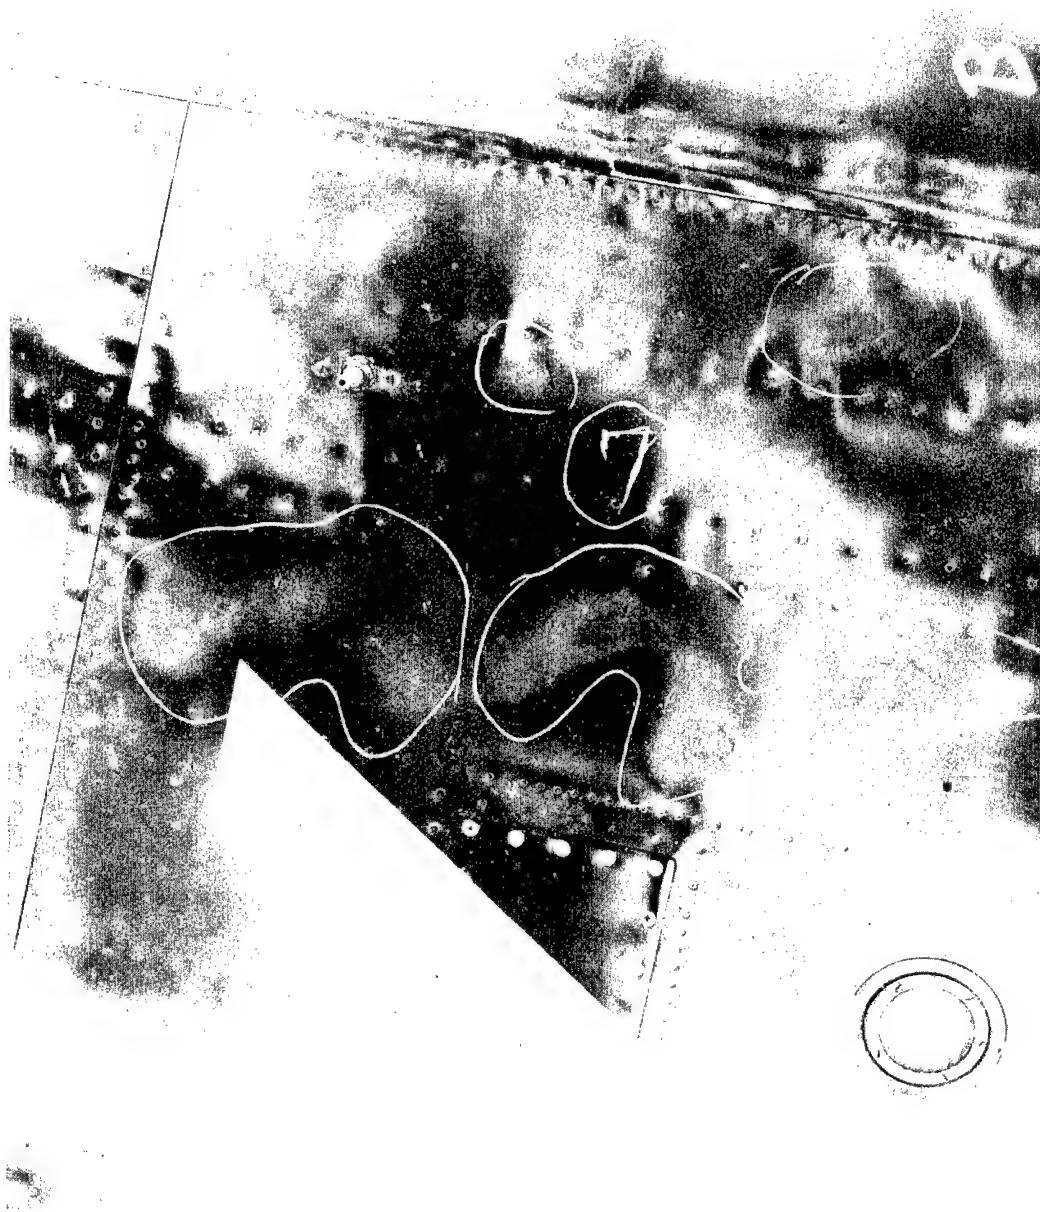
Fig. 2.8 AD-2, Aperture between Elevator and Horizontal Stabilizer Showing Destroyed Rubberized Fabric Aerodynamic Seal - Shot 2

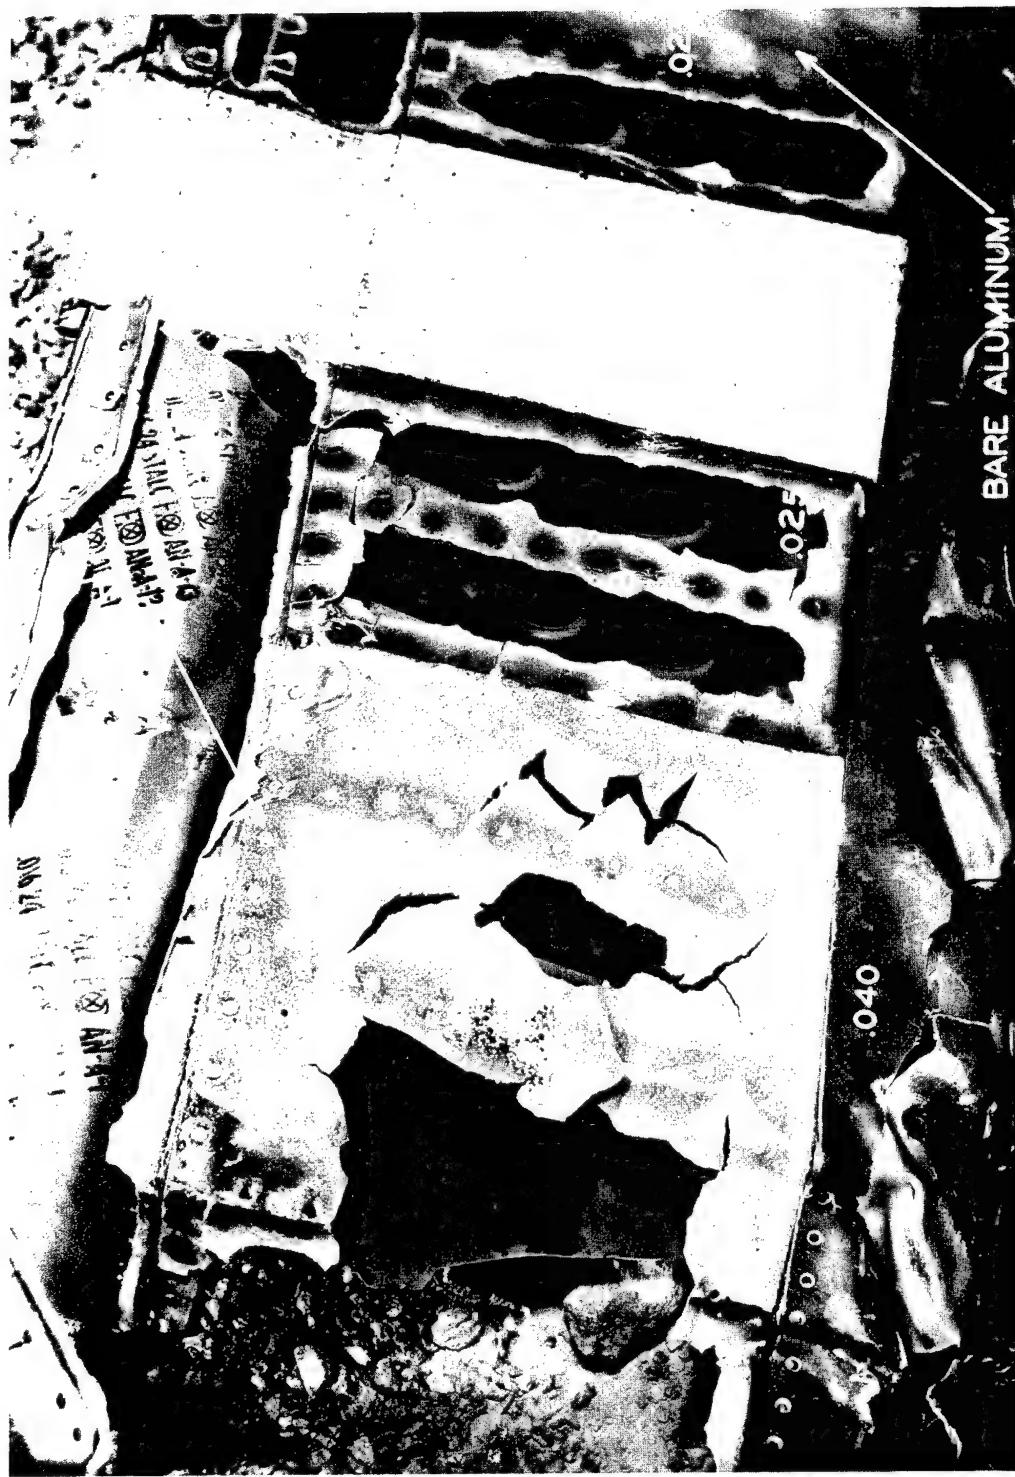
The fabric lightening hole covers destroyed in Shot 2 were replaced with fabric covers coated with aluminized lacquer. These covers were slightly scorched but not burned through (see Fig. 2.19). Aileron seals remained intact (see Fig. 2.11). The top side of the wing gave no indication of thermal damage other than softening of standard blue paint on 0.016 skin on the aileron (see Fig. 2.20) where the under side skin was completely destroyed.

Fig. 2.11 AD-2. Port Aileron Showing Aileron Seal Intact - Shot 7

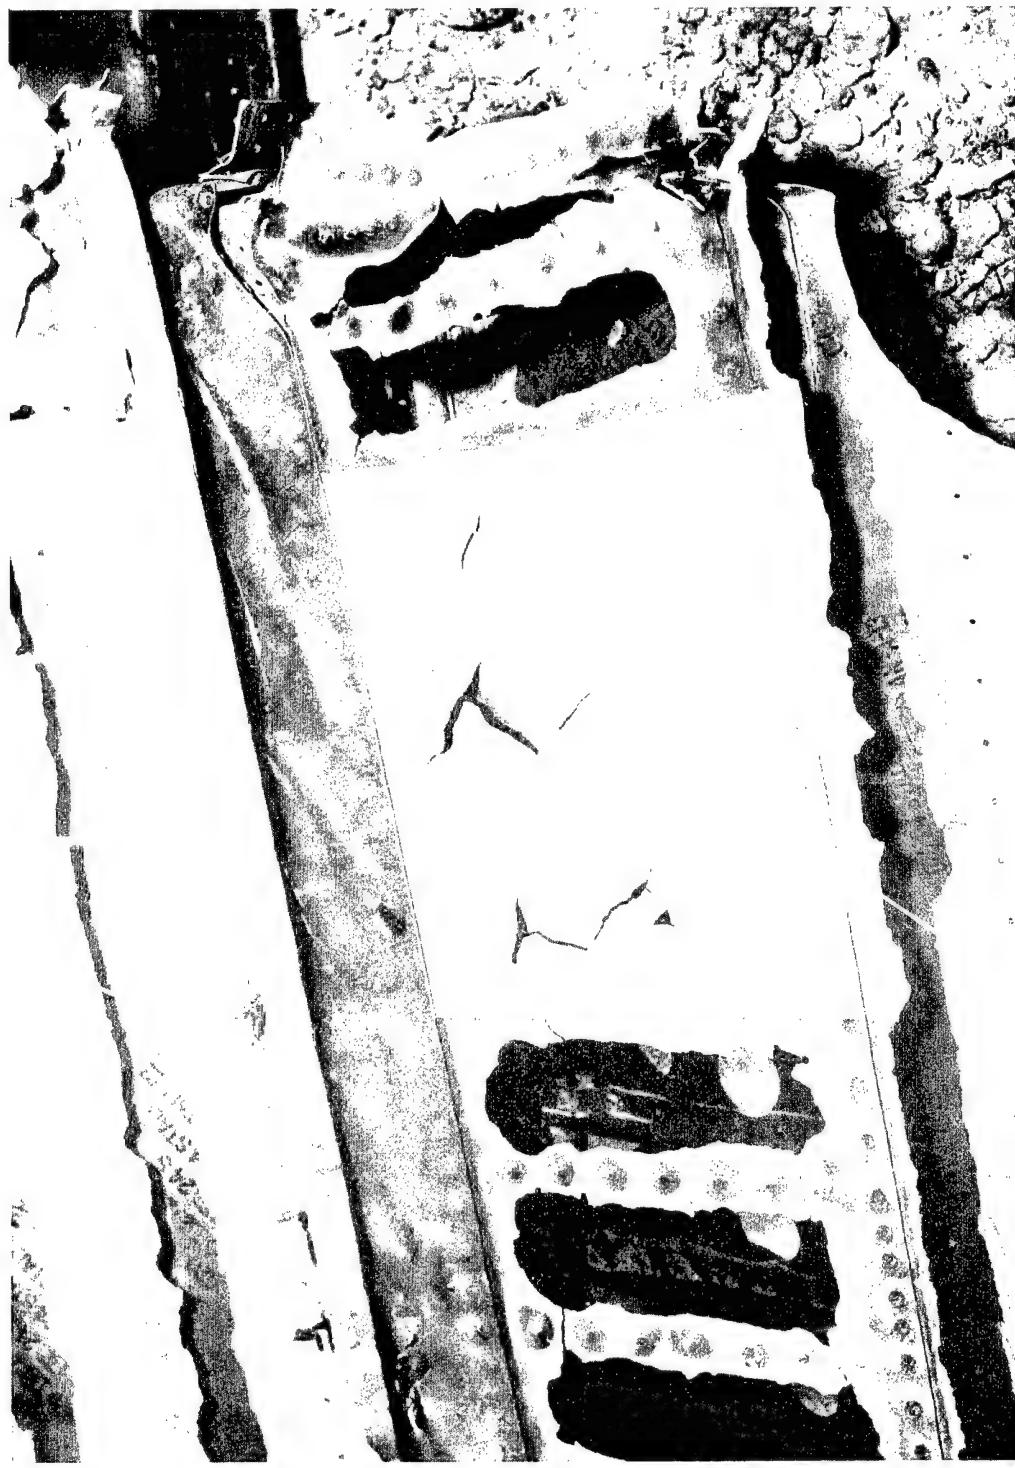
Surface Finish	Effects	Figure No.
	<u>0.016 Skin Thickness</u>	
Standard Blue	Panels missing except for small circular pieces around each rivet	2.10; 2.11
Standard White	Panels missing except for edges	2.12; 2.19
Aluminized Lacquer	Panels missing except for edges	2.13; 2.14
Heat Resistant White	Panels remained intact	2.15
Bare Aluminum	Pieces missing; panel broken along center line	2.15
	<u>0.025 Skin Thickness</u>	
Standard Blue	Panel missing except for edges	2.10; 2.13
Standard White	Pieces missing; panel broken along center line	2.12
Aluminized Lacquer	Panel broken along center line	2.13

Fig. 2.12 AD-2, Port Aileron - Showing Relative Damage to Various Combinations of Surface Finish and Skin Thickness - Shot 7

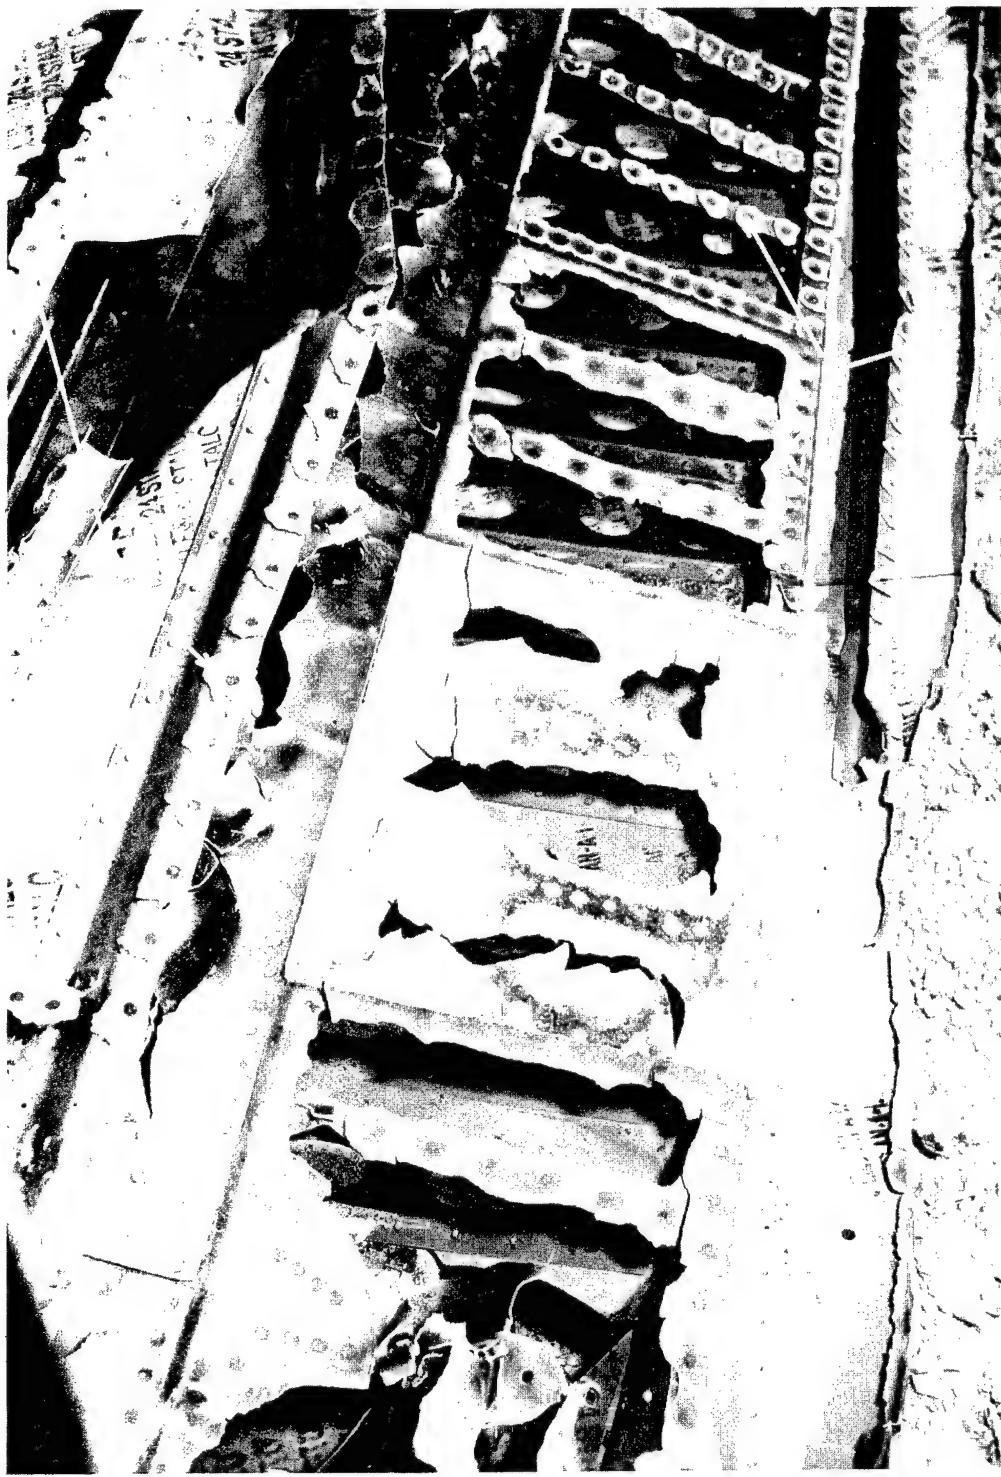
Fig. 2.13 AD-2, Starboard Aileron - Showing Thermal Damage to Aluminized Lacquered 0.025 Skin Compared with Standard Blue Painted 0.025 Skin - Shot 7

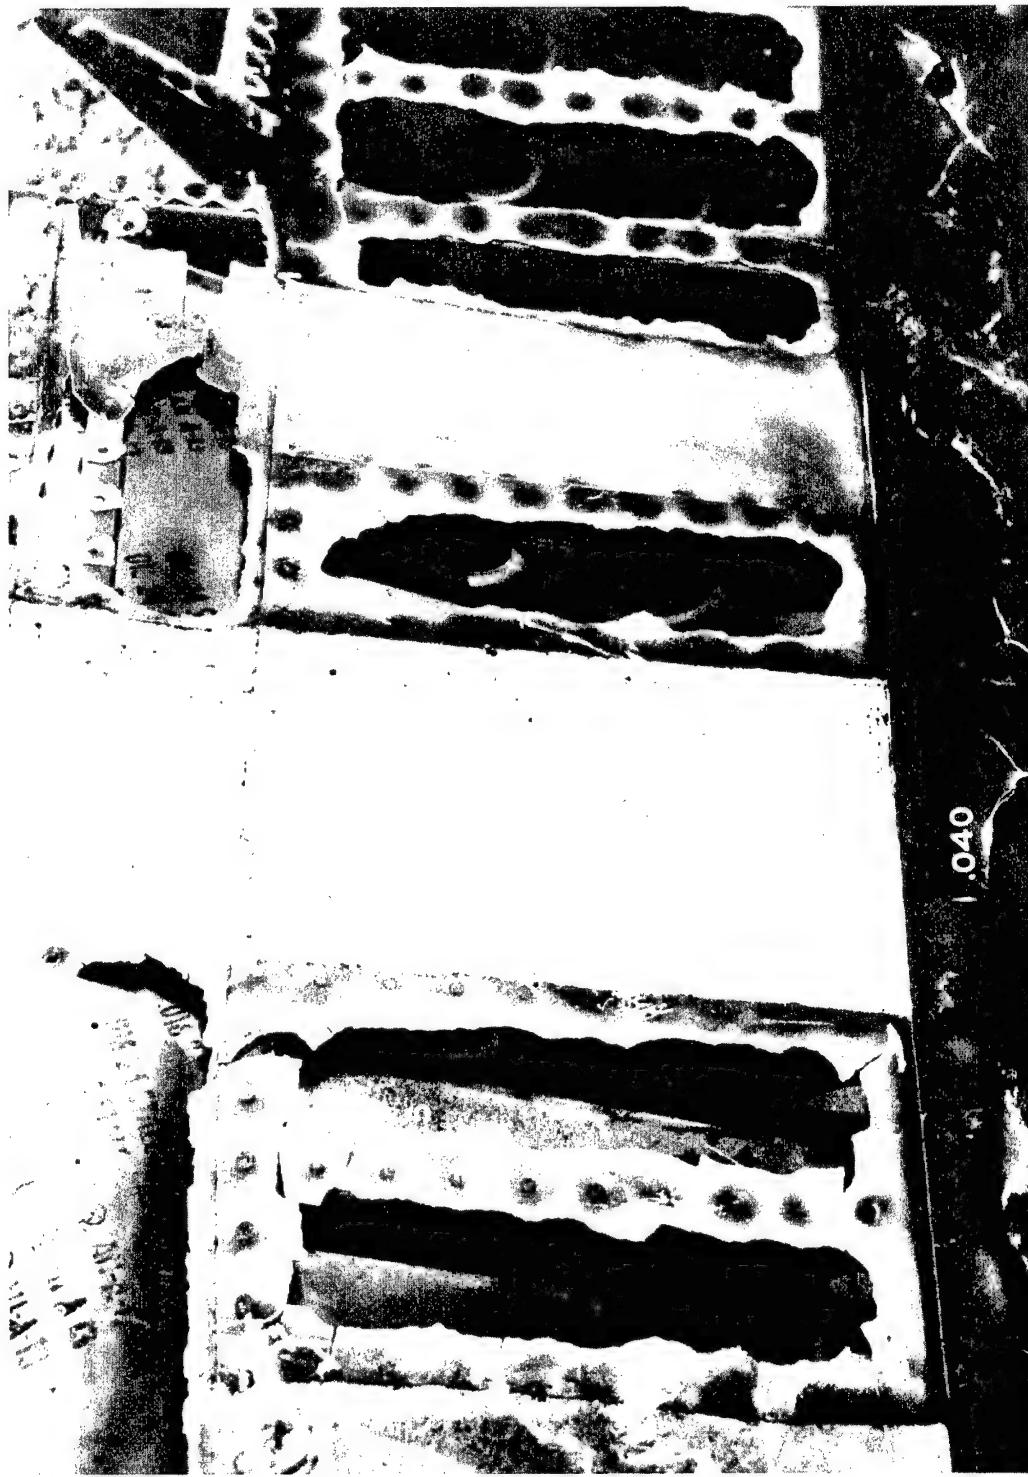
Surface Finish	Effects	Figure No.
Aluminized Lacquer	Pieces missing; panel broken along center line	2.14
Heat Resistant White	Panels remained intact	2.15
Bare Aluminum	Panels remained intact	2.15
Standard Blue	<u>0.032 Skin Thickness</u> Panel missing except for edges. NOTE: White lettering gave added protection.	2.16
Heat Resistant White	Panel remained intact	2.17
Standard Blue	<u>0.040 Skin Thickness</u> Pieces missing; panel broken along center line, except on narrow panels. NOTE: White lettering gave added protection.	2.18; 2.14; 2.16
Aluminized Lacquer	Panel remained intact	2.18
Standard Blue	<u>0.051 Skin Thickness (AL-3-SO)</u> Skin apparently unaffected; paint scorched	2.16

Fig. 2.14 AD-2, Port Aileron - Showing Thermal Damage to Aluminized Lacquered 0.025 Skin Compared with Standard Blue Painted 0.025 Skin - Shot 7

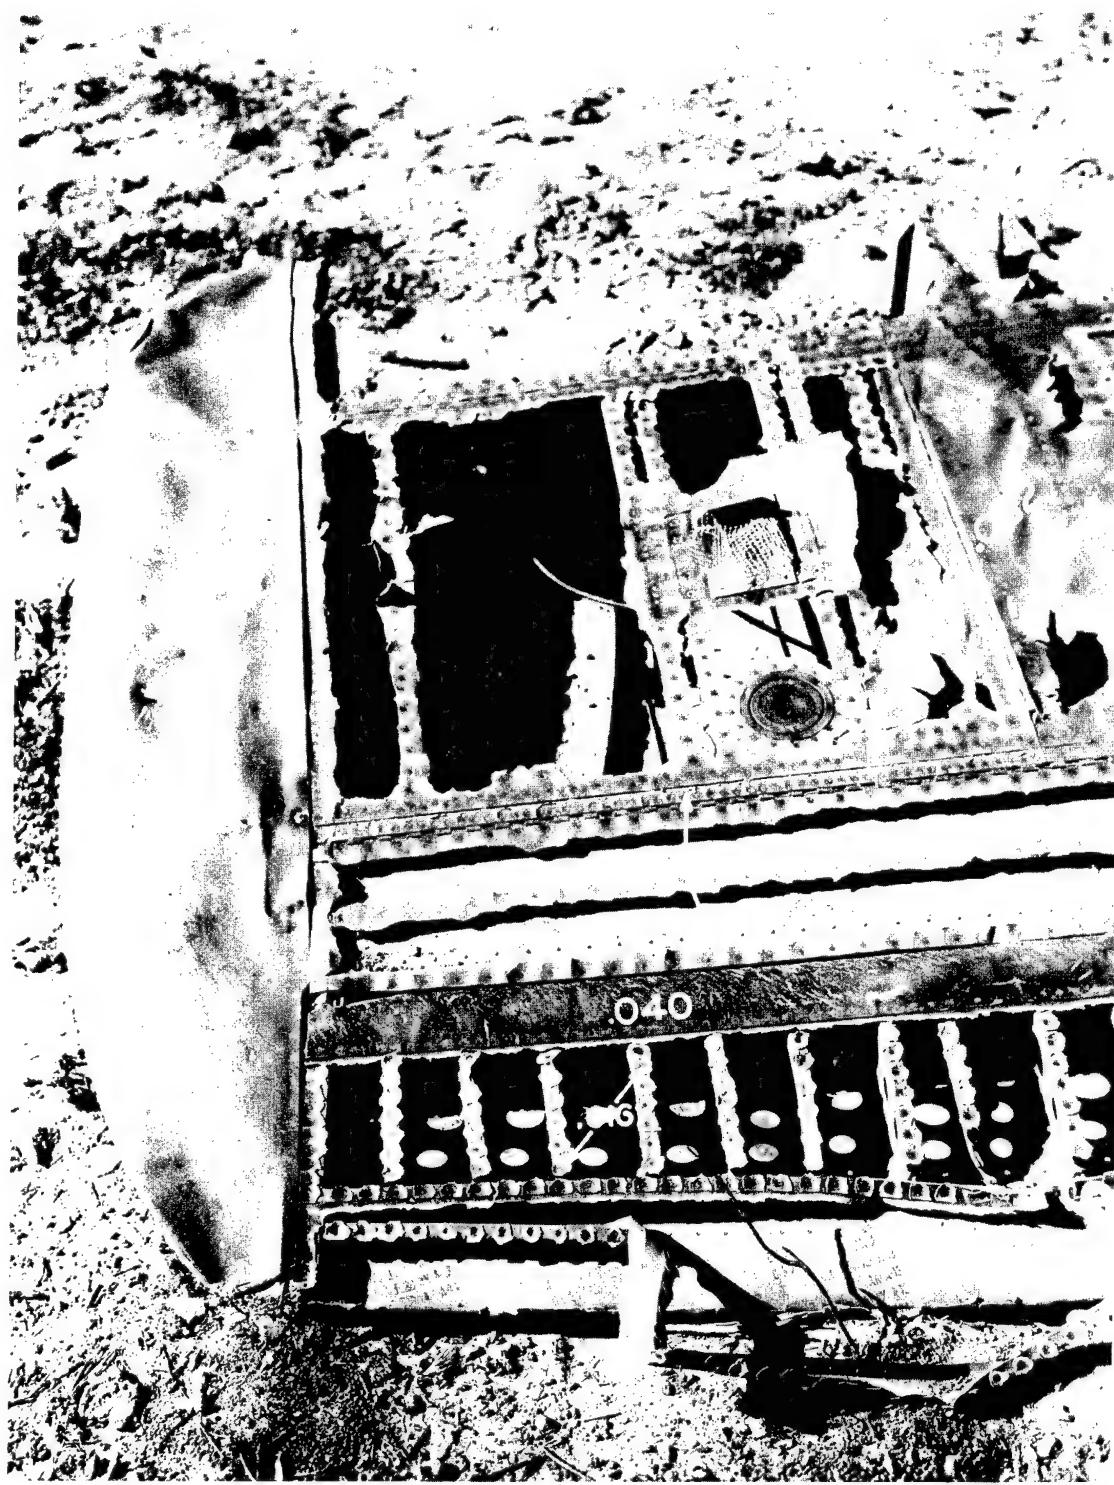
Fig. 2.15 AD-2, Port Aileron - Showing Relative Damage to Various Combinations of Surface Finish and Skin Thickness - Shot 7

The extreme importance of aircraft skin surface finish is readily seen in the results from Shot 7. Heat resistant white painted panels remained intact where similar panels with standard blue paint, subjected to identical thermal radiation, were completely destroyed. Bare aluminum held up almost as well as heat resistant white but in all cases experienced higher temperatures. It is to be noted here that heat resistant white and standard white paint afford roughly the same protection as long as the finish is not charred. At thermal levels high enough to seriously affect the standard white surface, it proves to be no better than aluminized lacquer. Field analysis of the structural failures which caused loss of the drone in Shot 7 were conducted by project personnel and representatives of the Structures Department, Douglas Aircraft Co. Indications are that the aircraft might have survived had the under skin been bare aluminum or painted heat resistant white instead of standard blue.

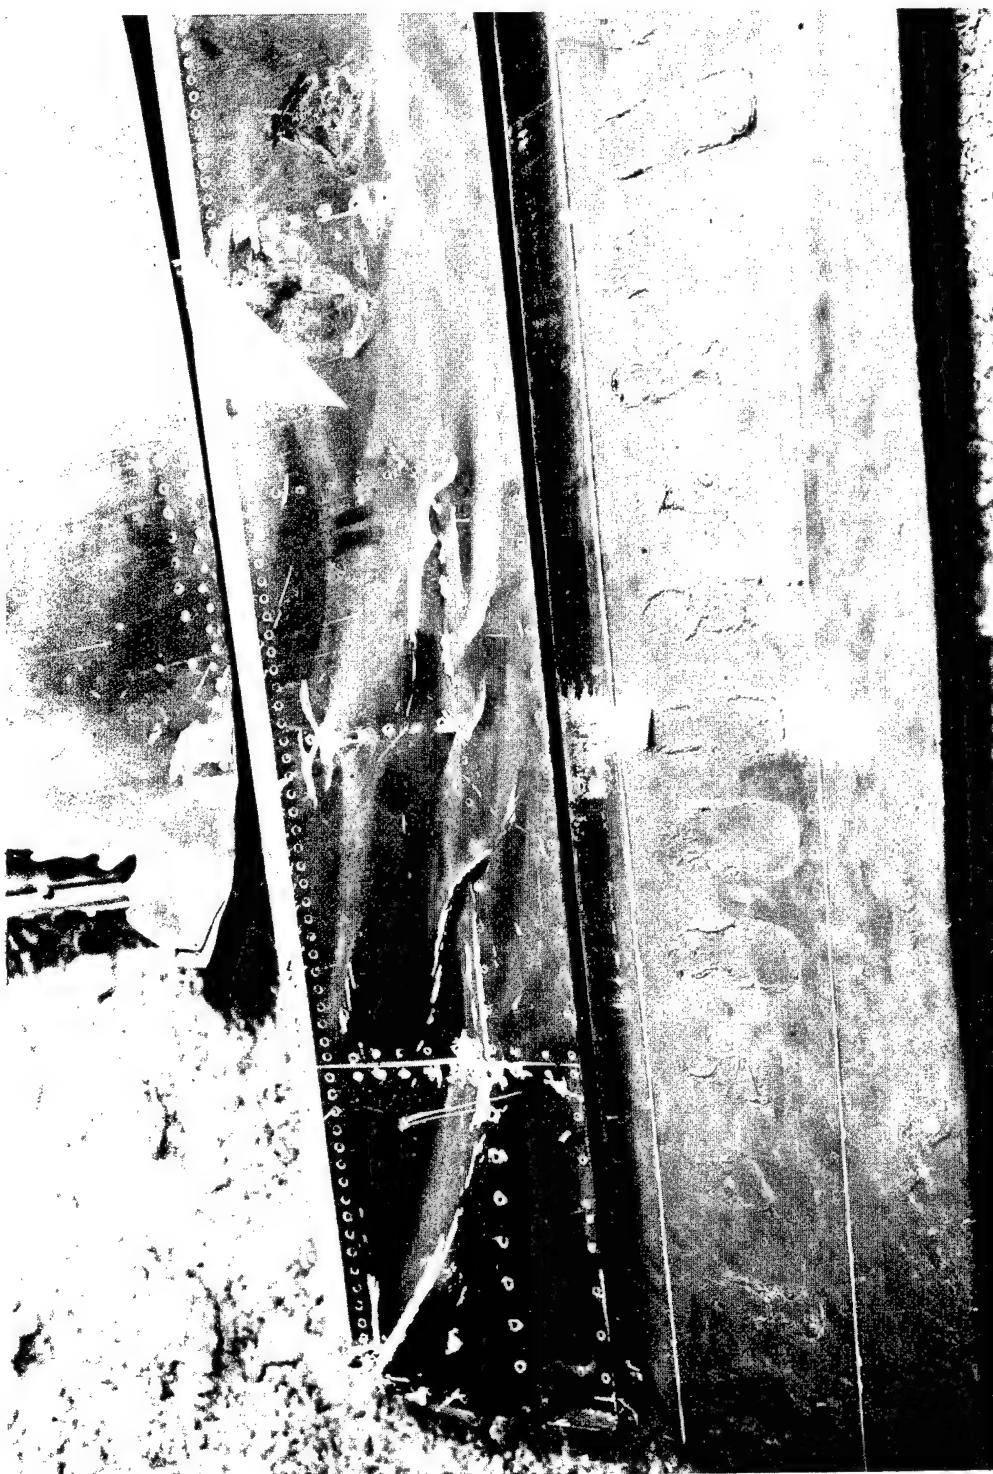
Fig. 2.19 AD-2, Tip of Elevator and Horizontal Stabilizer Showing Fabric-Lightening Hole Covers and Elevator Tip Intact - Shot 7

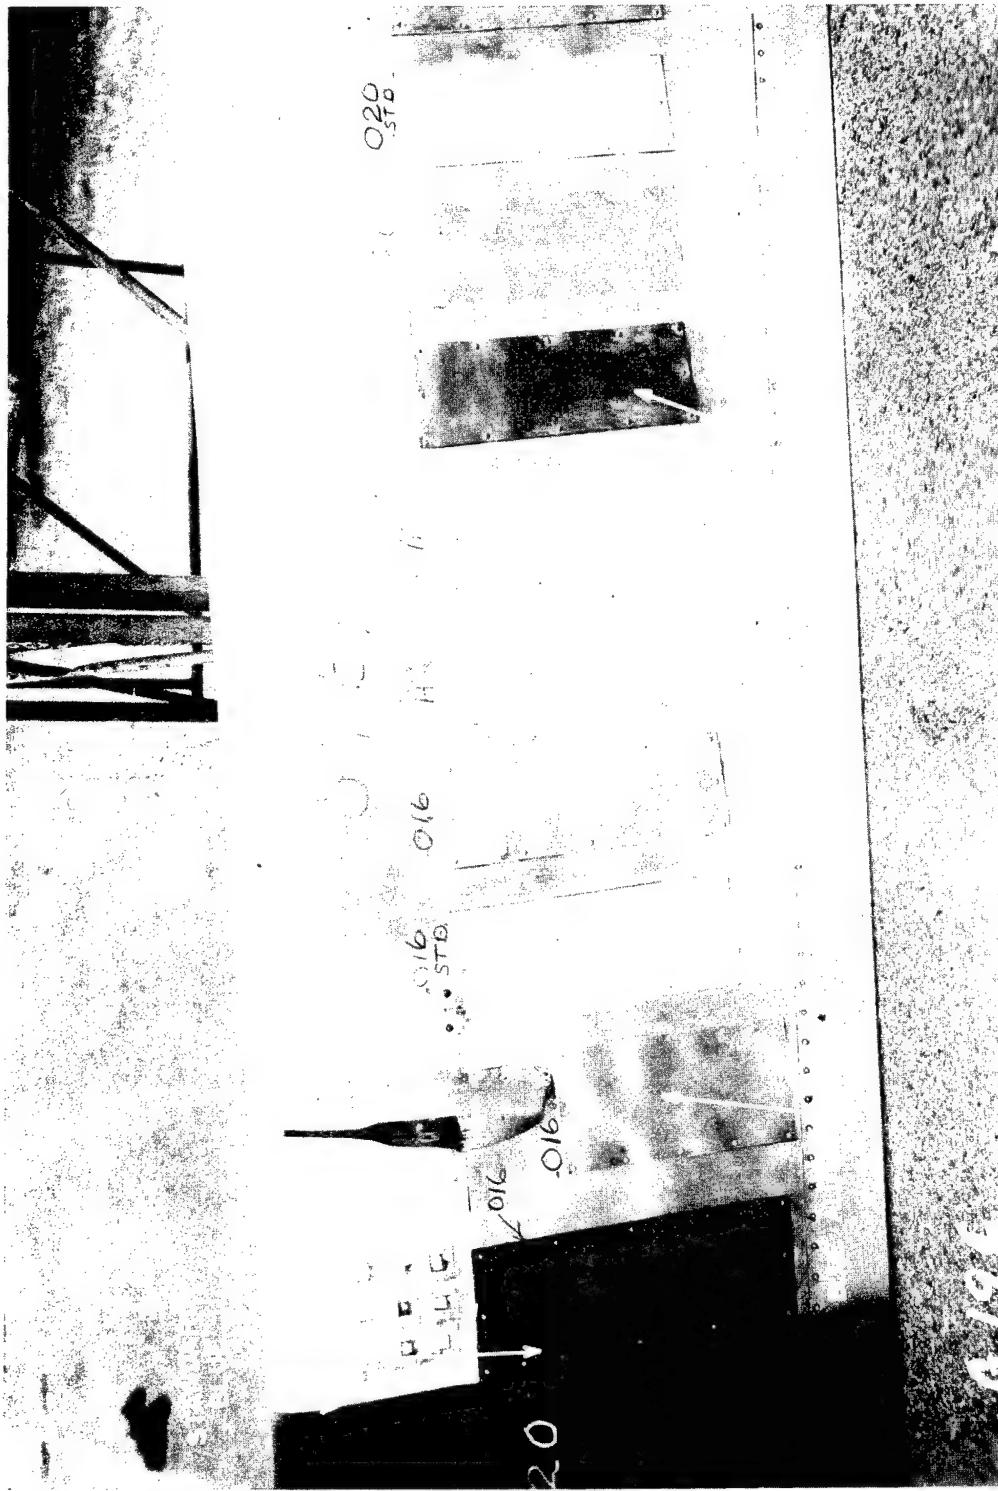
Fig. 2.23 XBT2D-1, Port Elevator Showing Scorched Painted Surfaces. Note skin ripples on 0.016 standard blue painted and aluminized lacquered surfaces. - Shot 8

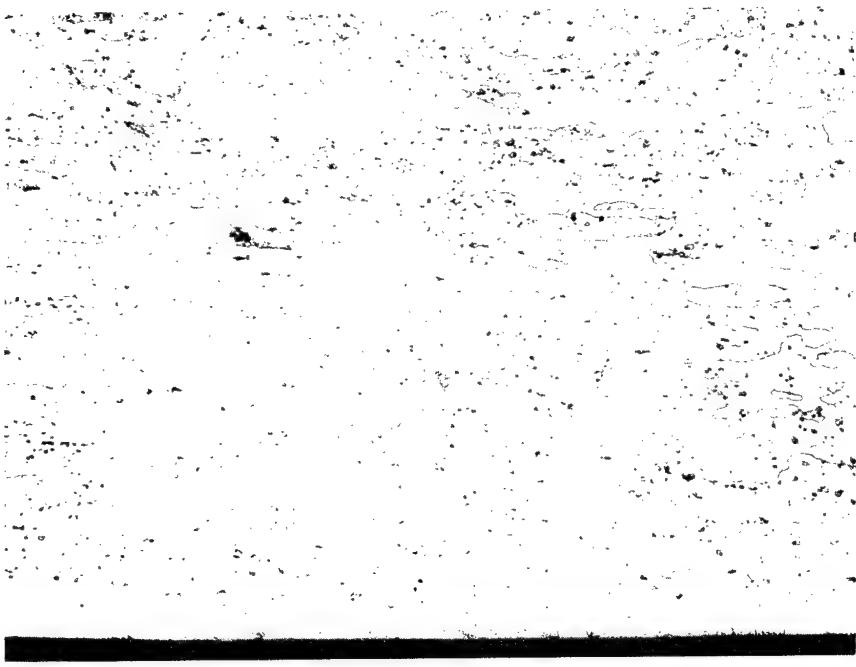
Description: Etched microstructure of submitted sample showing evidence of surface melting.

Fig. A.1 - Photomicrographs Showing Unaffected and Slightly Overheated Aluminum Alloy Sheets

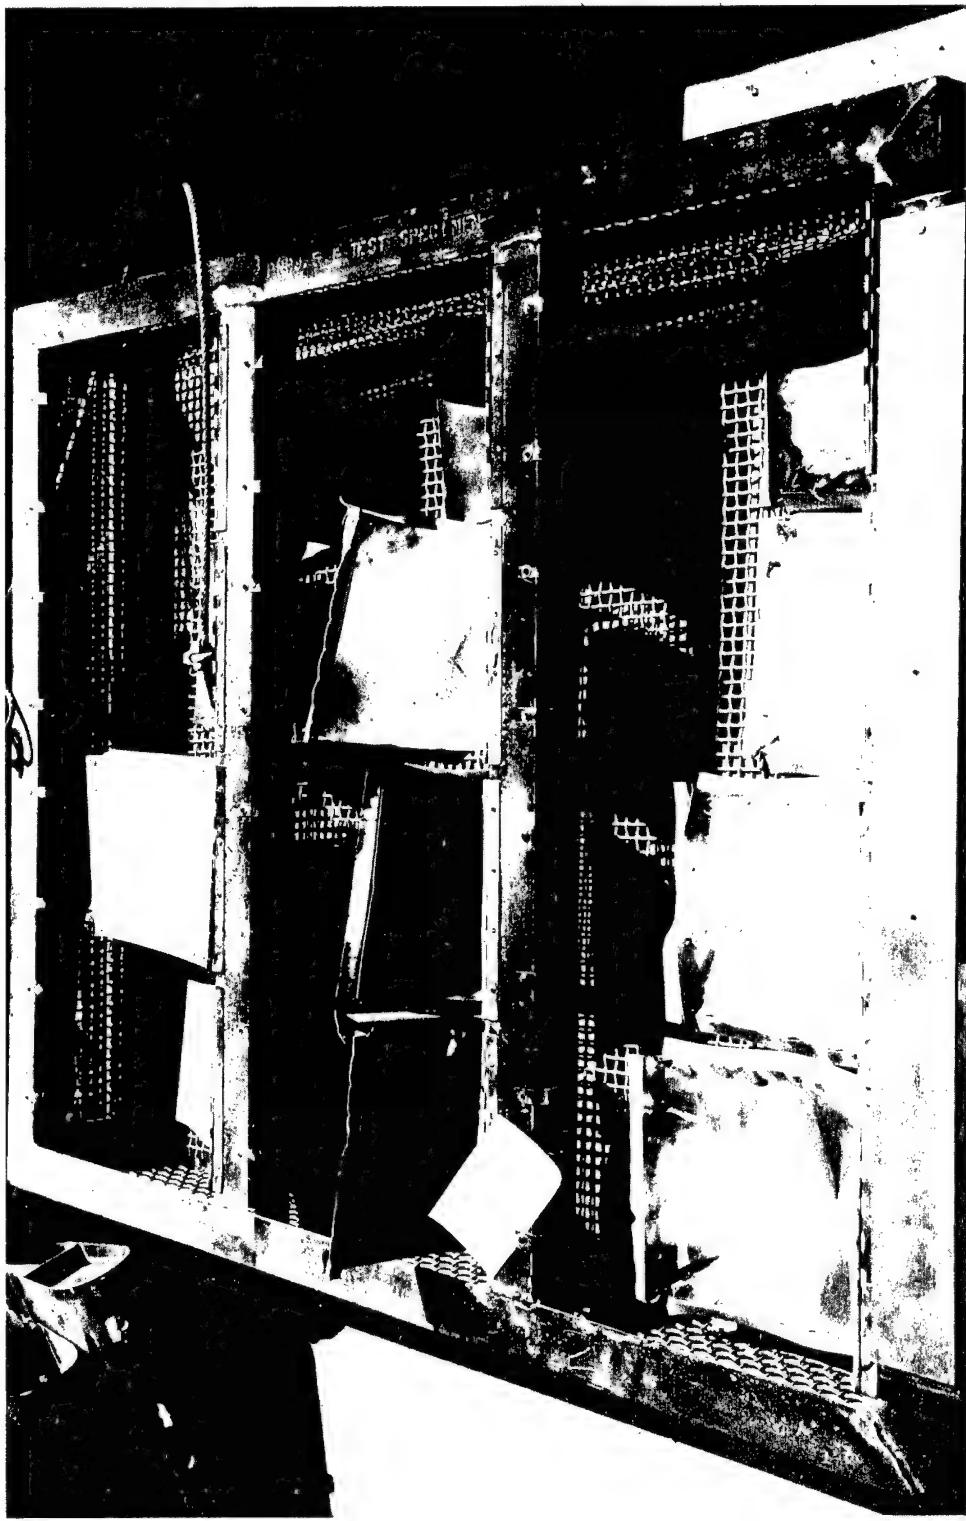
Fig. B.13 Frame Number 2 after Exposure - Slant  
Range 5330 Ft., Thermal Energy 30 cal/cm<sup>2</sup>

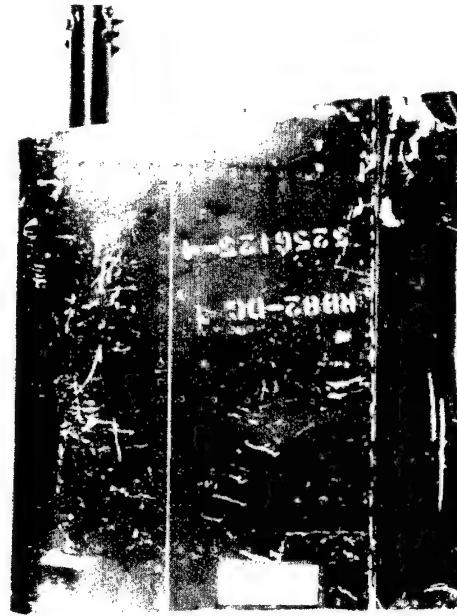
Fig. B.52 Elevator Section 1 - Exposed  
Side - Station 2

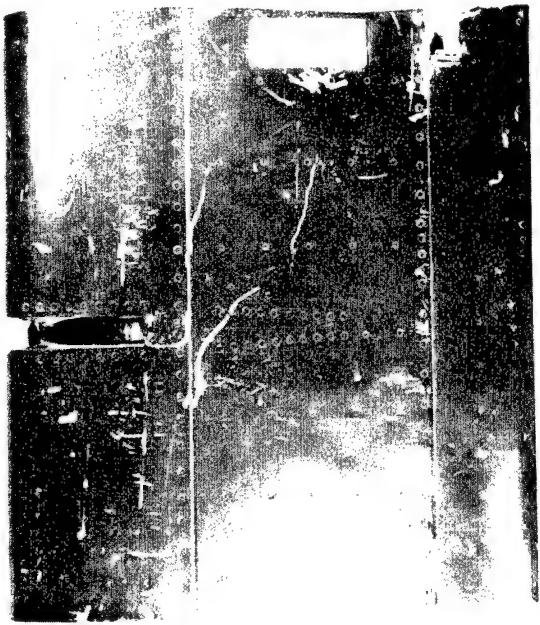
Fig. B.56 Elevator Section 3 - Exposed  
Side - Station 1
